# **Selected Images of the Effects of the October 15, 2006, Kīholo Bay-Māhukona, Hawai‘i, Earthquakes and Recovery Efforts**

Data Series 506

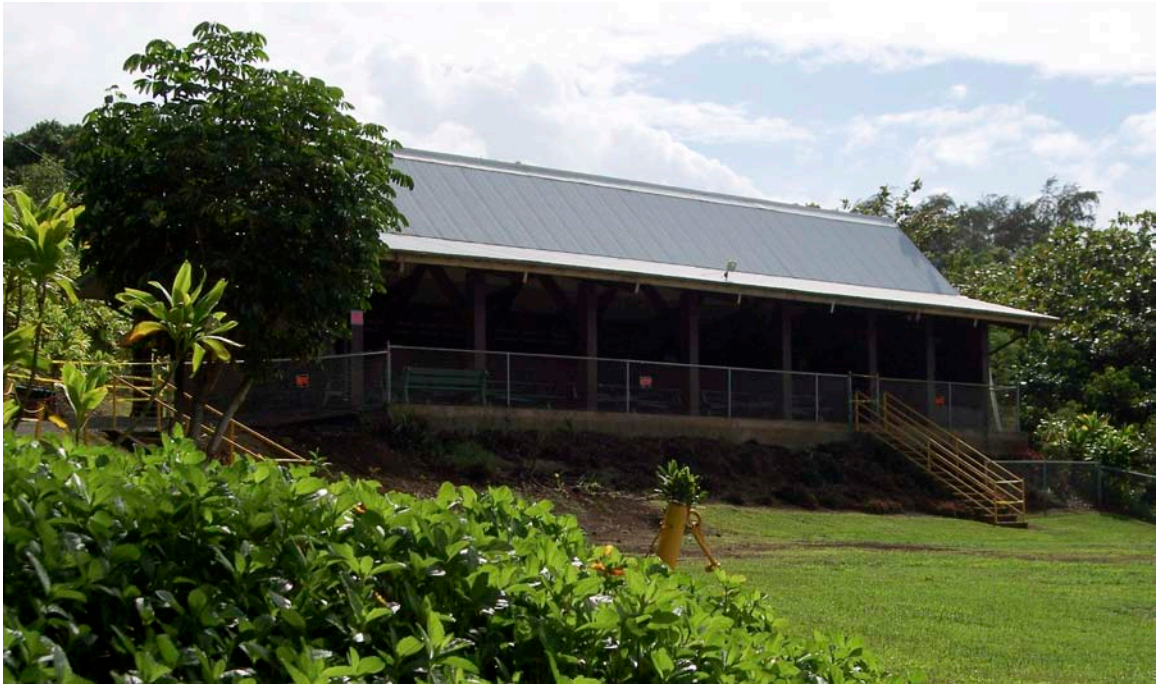
21.11. View of the red-tagged pavilion, marked unsafe to enter or occupy, at Kēōkea Beach Park (view to the south-southwest). USGS photo by T.J. Takahashi, 10/21/2006 (tjt1465).

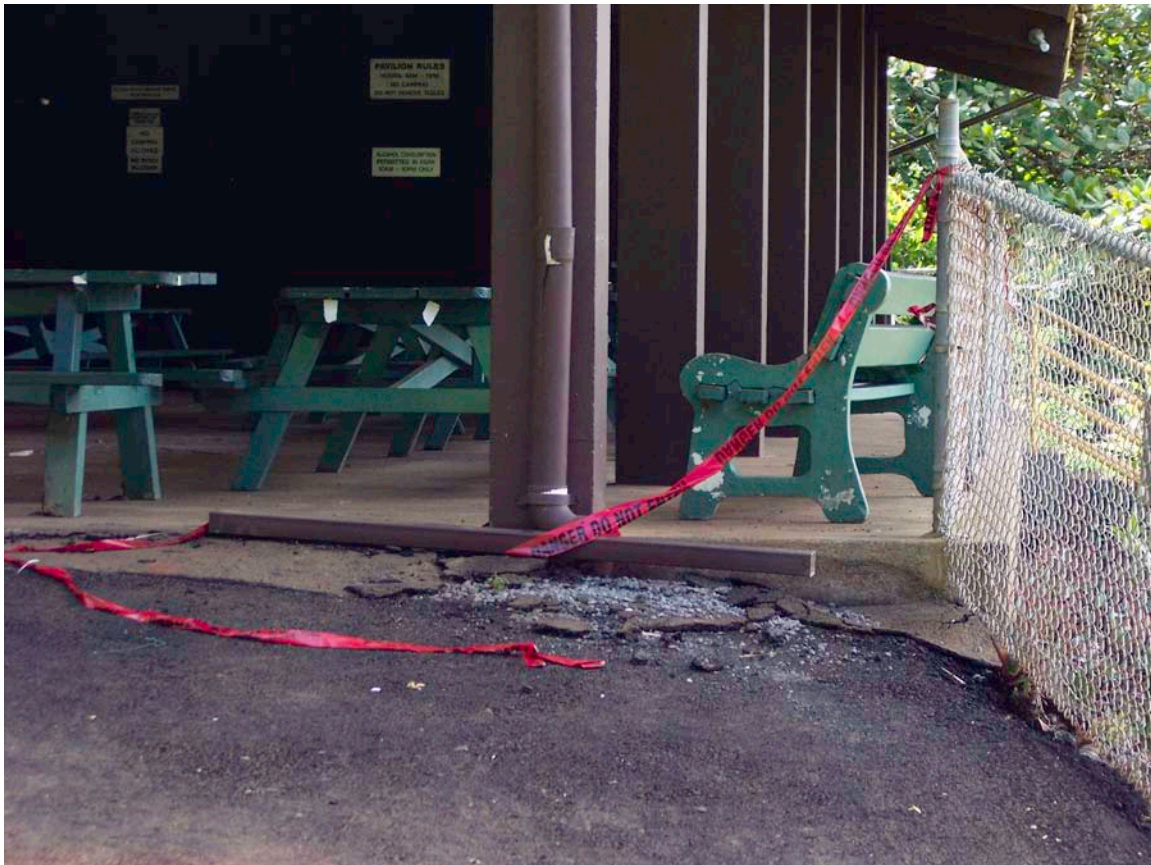
21.12. View of cracks in the pavement and rain-gutter pipe at the pavilion (view to the south-southwest). USGS photo by T.J. Takahashi, 10/21/2006 (tjt1458).

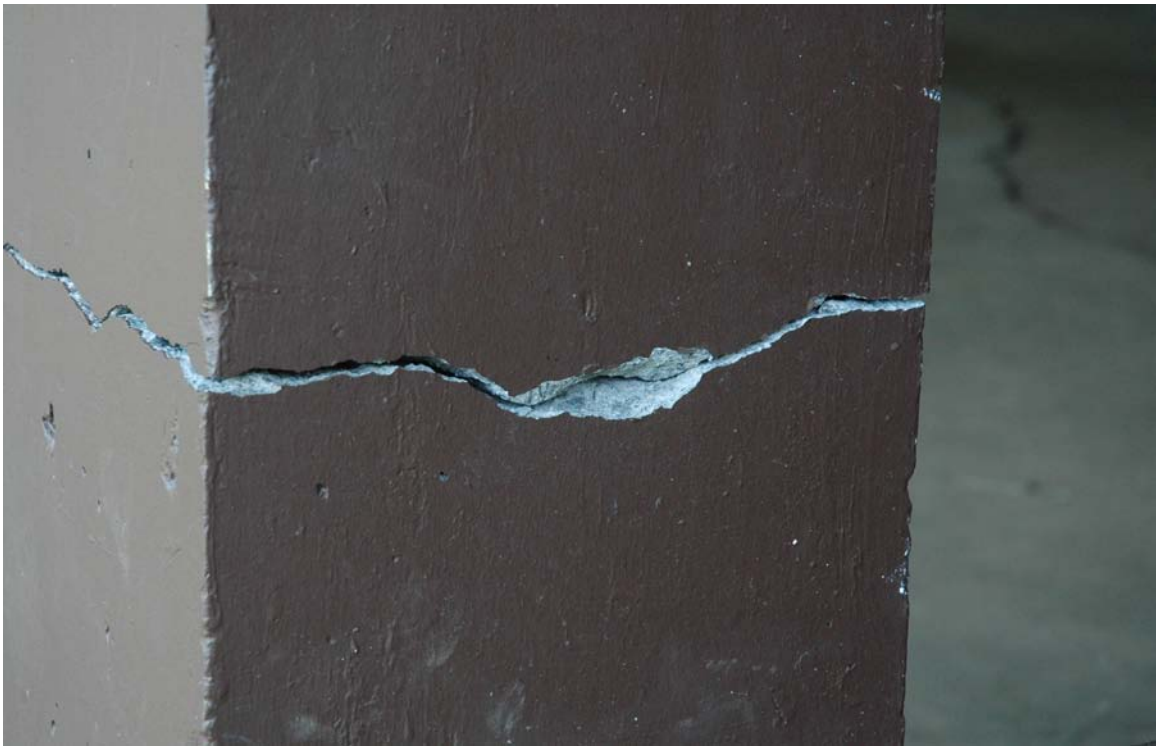
21.14. View of the crack in a concrete beam supporting the roof of the pavilion (view to the north-northwest). CSAV photo by D.A. Whilldin, 10/19/2006 (daw036).

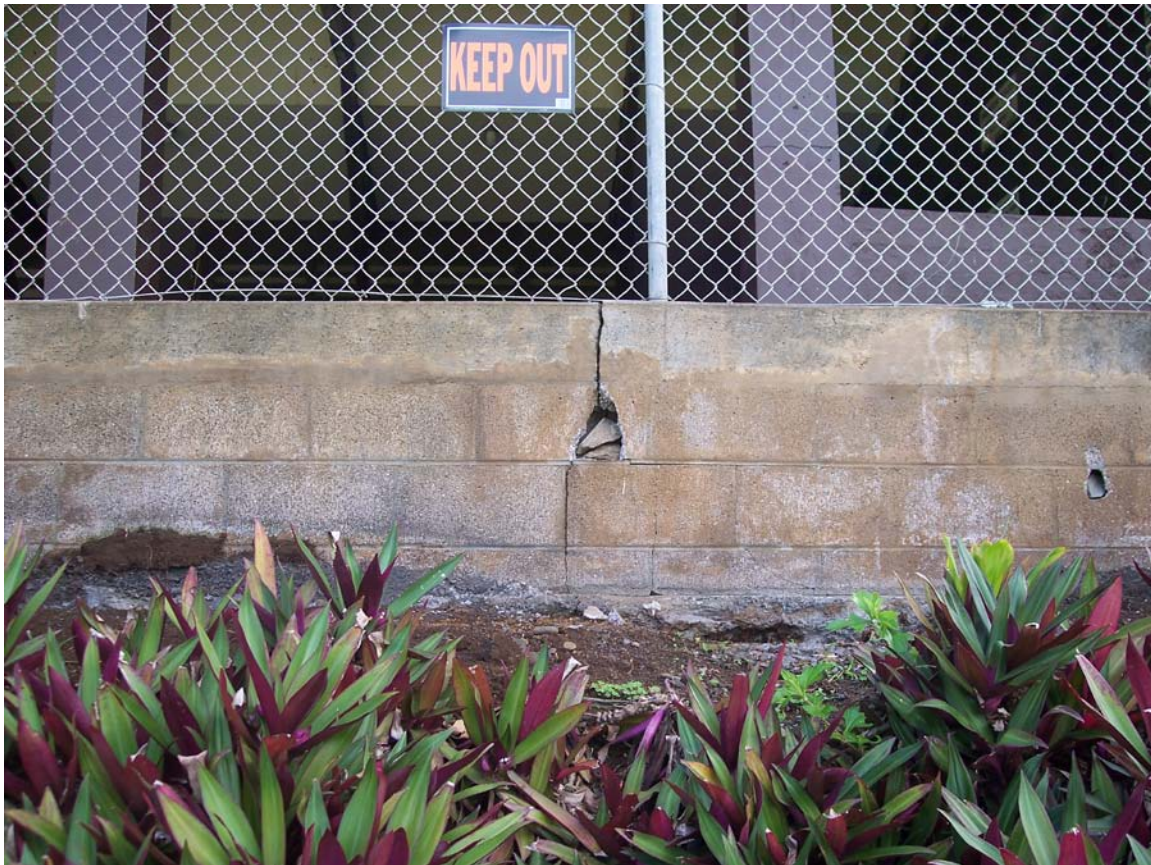
21.16. View of cracks in the cinder-block wall of the pavilion (view to the south-southeast). USGS photo by T.J. Takahashi, 10/21/2006 (tjt1459).

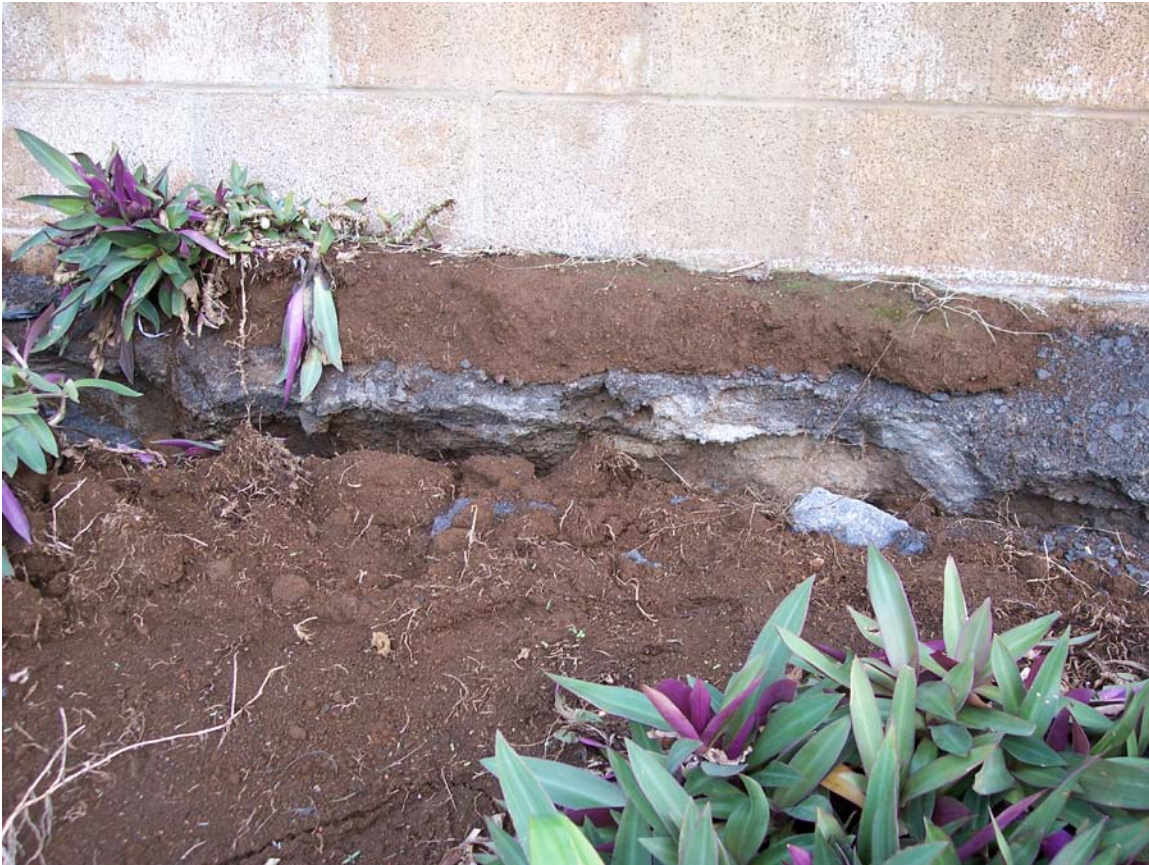
21.17. View of ground-slumping around the pavilion (view to the south-southeast).  
USGS photo by T.J. Takahashi, 10/21/2006 (tjt1462).

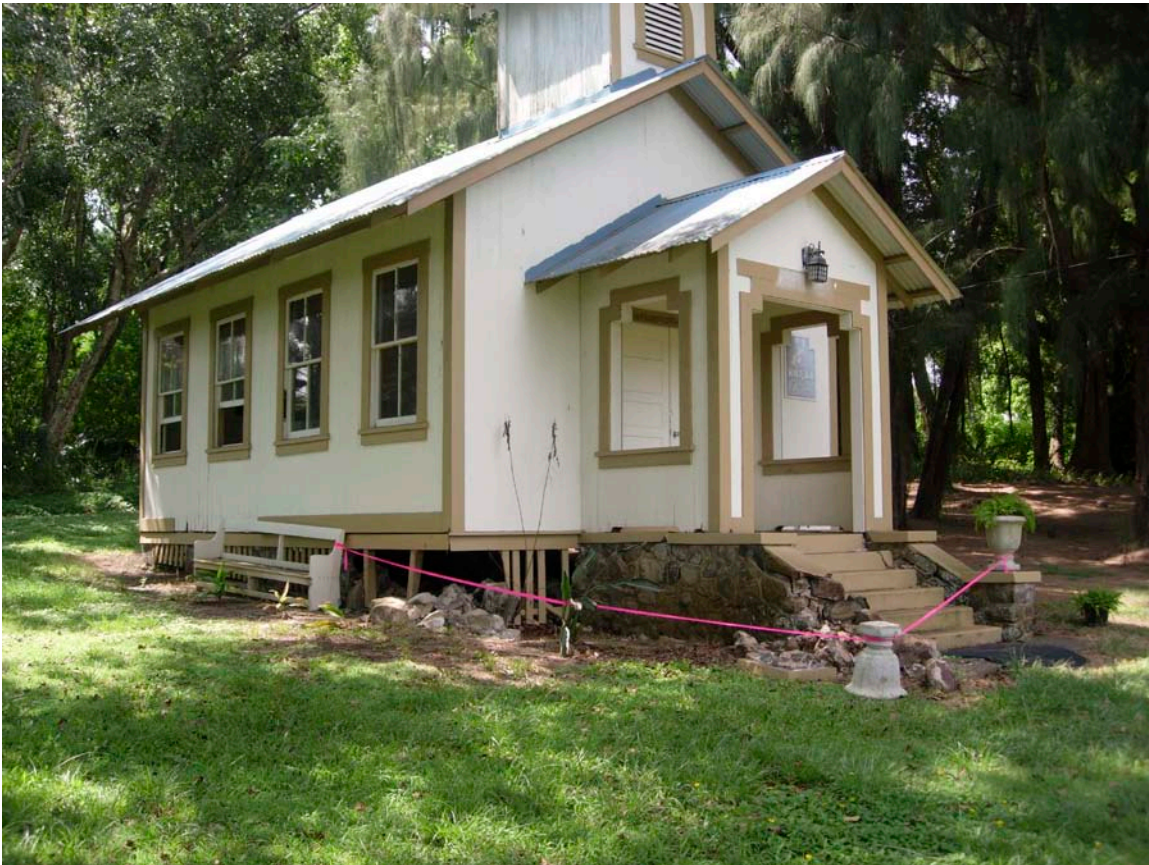
22.1. View of the collapsed vertical wooden poles and battens, cemented corner rock pillar, and rock railing of the front steps and entryway (viewed to the southwest). USGS photo by M.P. Poland, 10/19/2006 (mpp001).

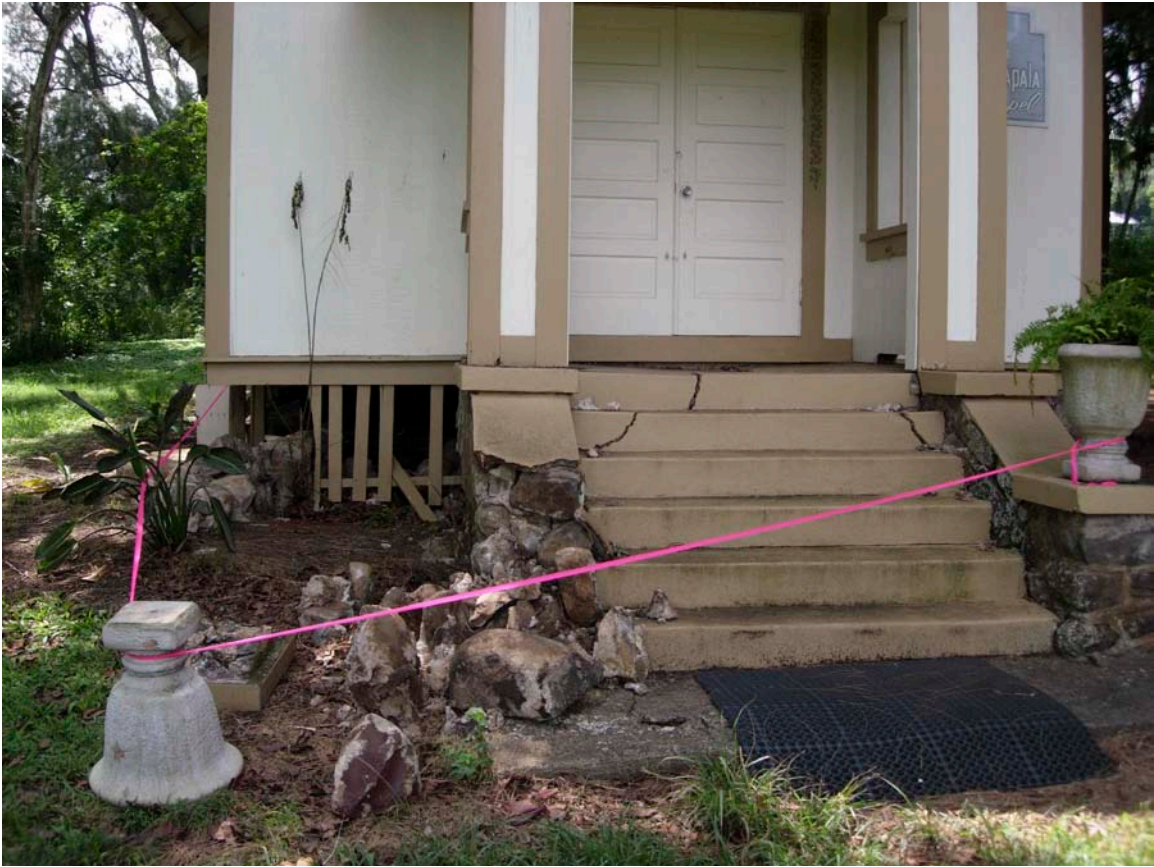
22.2. Close-up view of the collapsed stone-wall railing and front steps (view to the south). USGS photo by M.P. Poland, 10/19/2006 (mpp002).

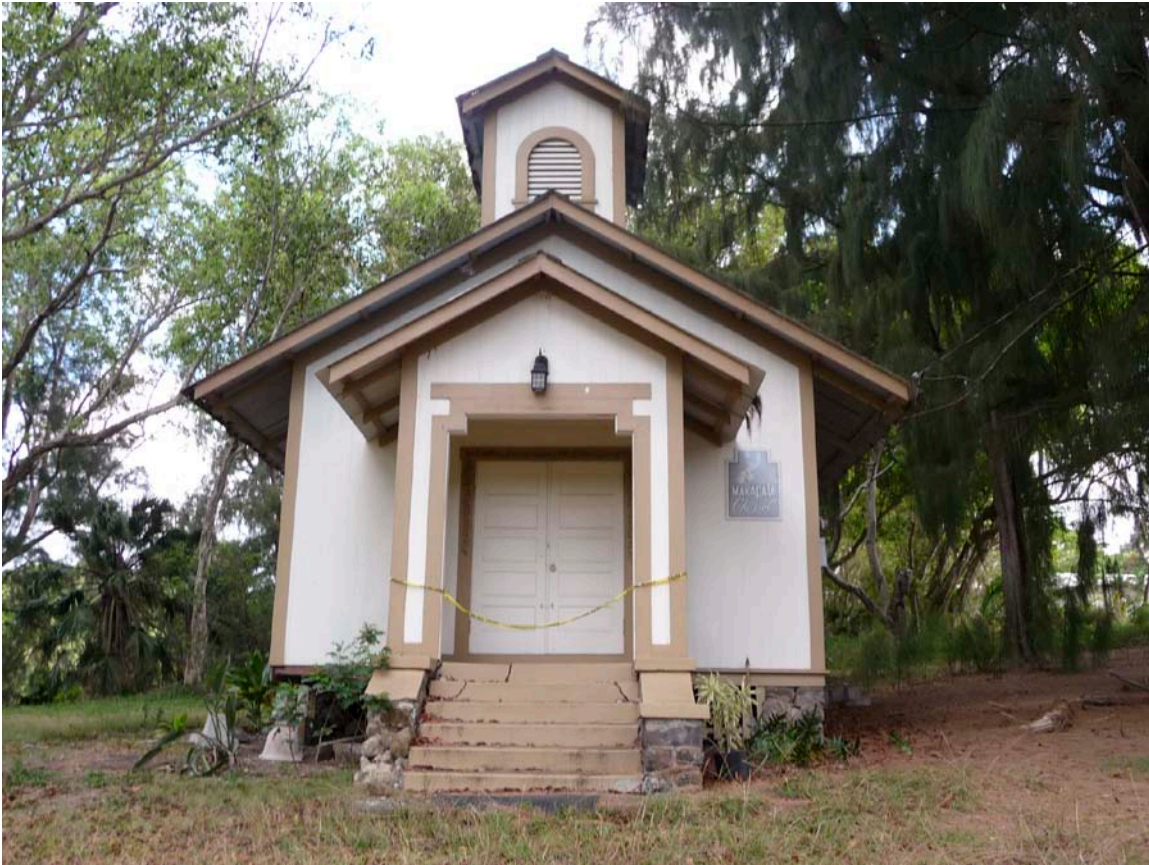
22.4. Cracked rock support for the front steps and entryway at Makapala Chapel await repairs (view to the south). USGS photo by N.A. Ikeda, 7/26/2008 (nai018).

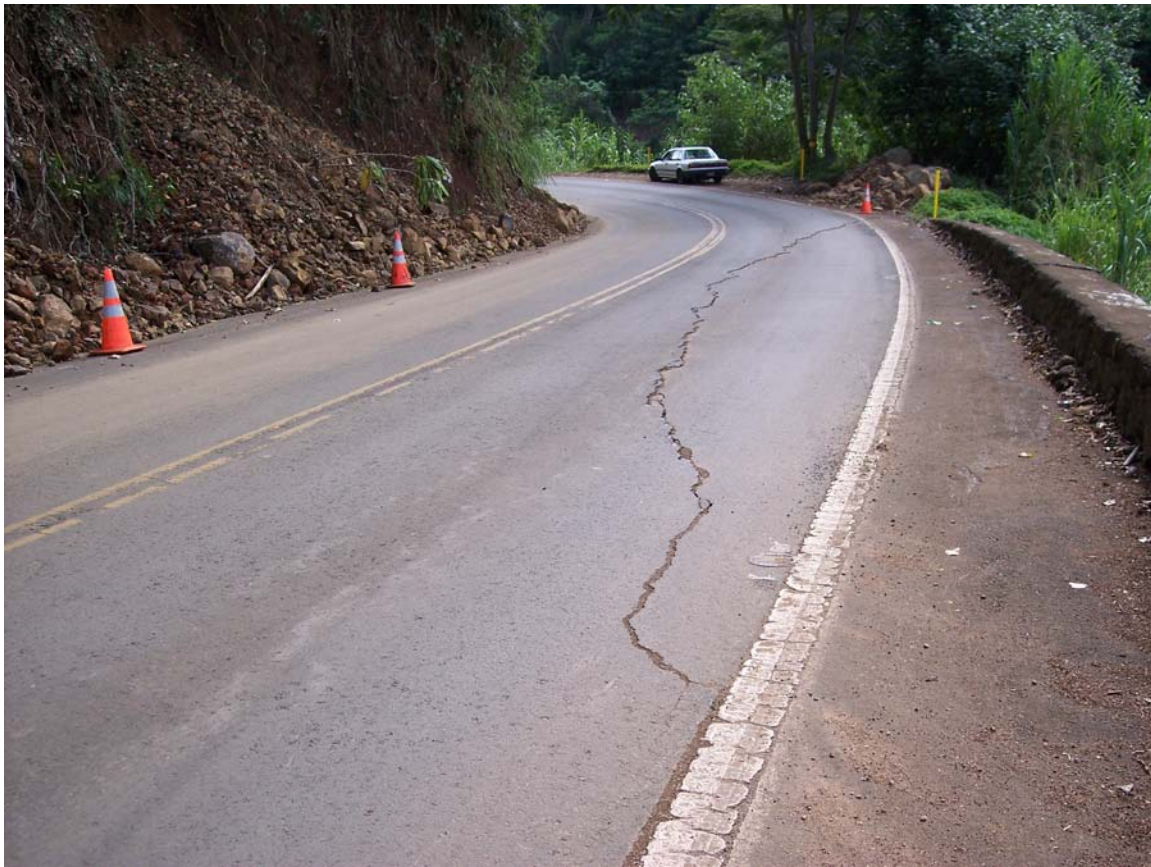
23.1. View of the earthquake's effects: the rock-fall debris, swept to the side of the road cut, the crack zigzagging into the roadway, and cracks in the concrete guard wall at Pūwā‘i‘ole Gulch (view to the southwest). USGS photo by T.J. Takahashi, 10/21/2006 (tjt1535).

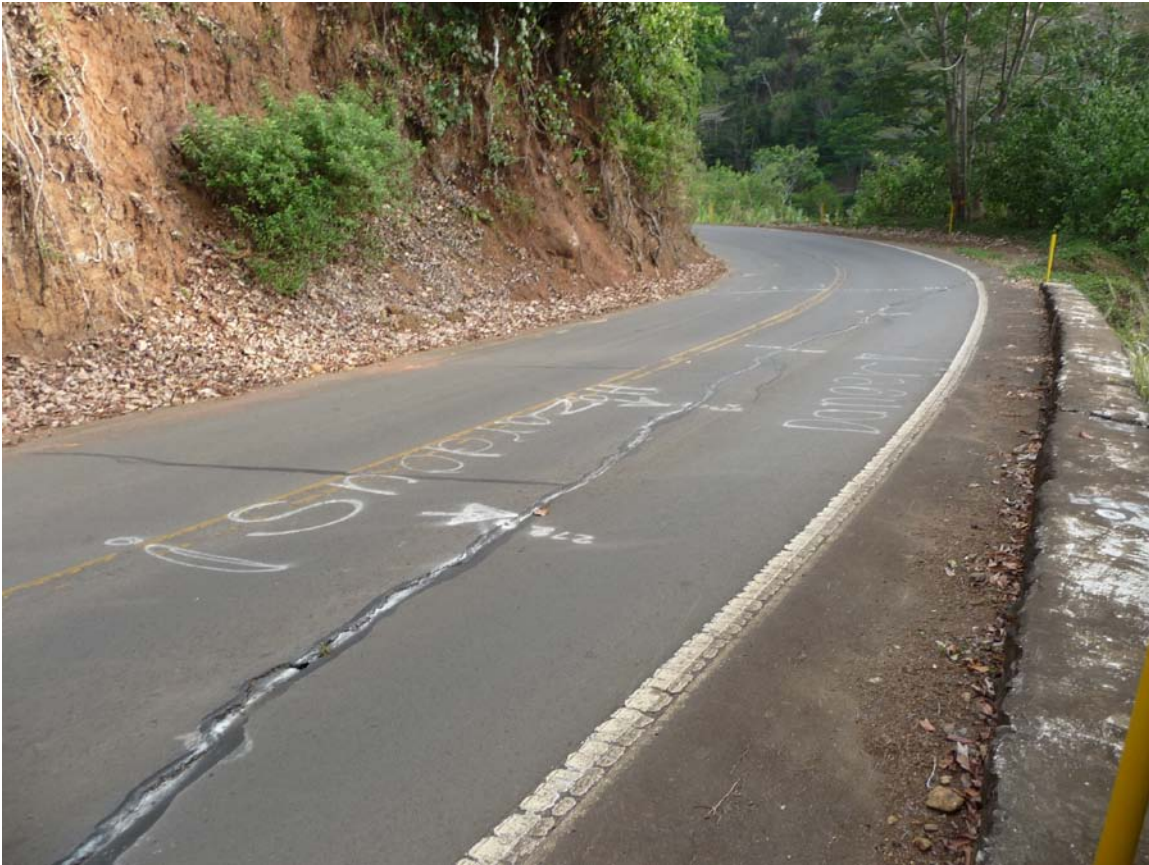
23.2. View of the cleared roadside debris (see photo 23.1, tjt1535) and cracks in the road, sealed and labeled “Danger” and “Hazardous” (view to the southwest). USGS photo by N.A. Ikeda, 7/26/2008 (nai1022).

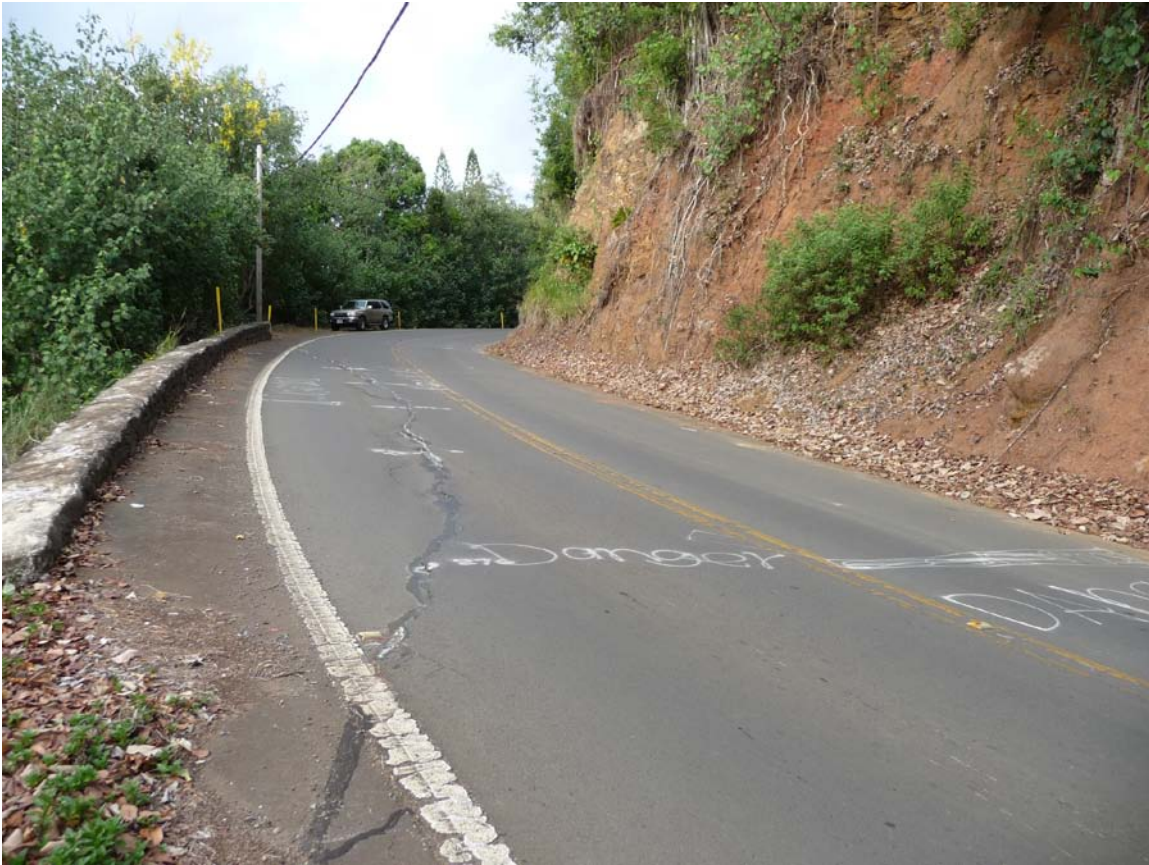
23.3. View of the sealed road cracks and words of warning on the road (view to the northeast). USGS photo by N.A. Ikeda, 7/26/2008 (nai1024).

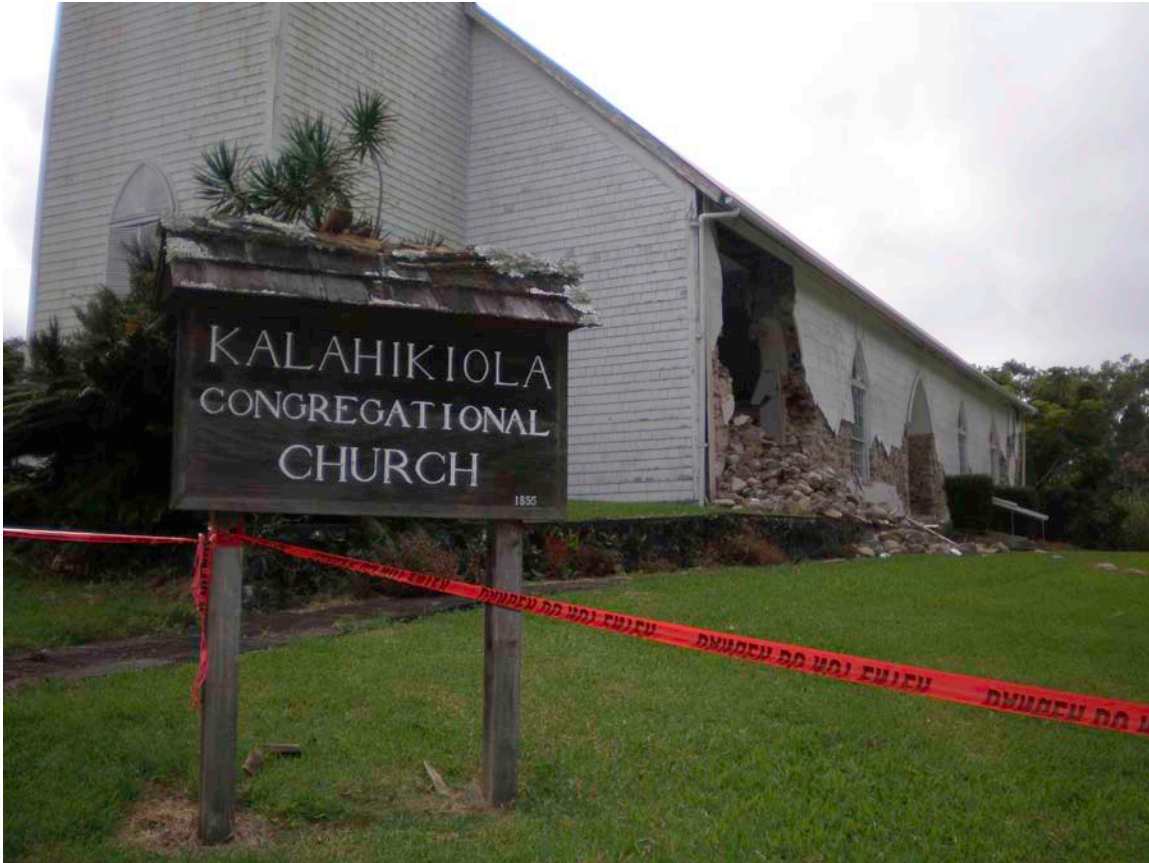
24.1. View, from the east, along the north wall of Kalāhikiola Congregational Church. The church, red-tagged as unsafe to enter or occupy, sustained extensive damage to the interior and exterior walls, ceiling, windows, and floor (view to the west-southwest). USGS photo by C. Francos, 10/17/2006 (cf056).

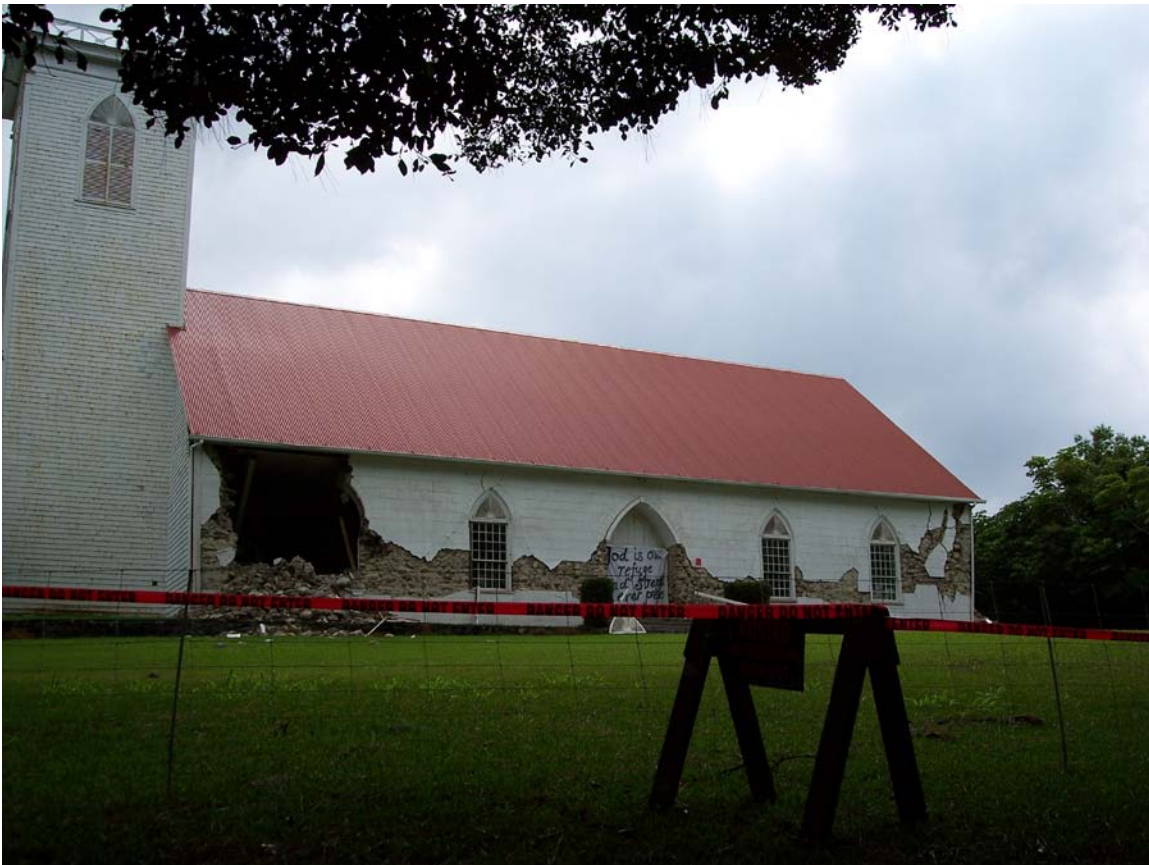
24.2. View of damage to the rock and stucco exterior of the north wall (view to the southwest). USGS photo by T.J. Takahashi, 10/20/2006 (tjt1357).

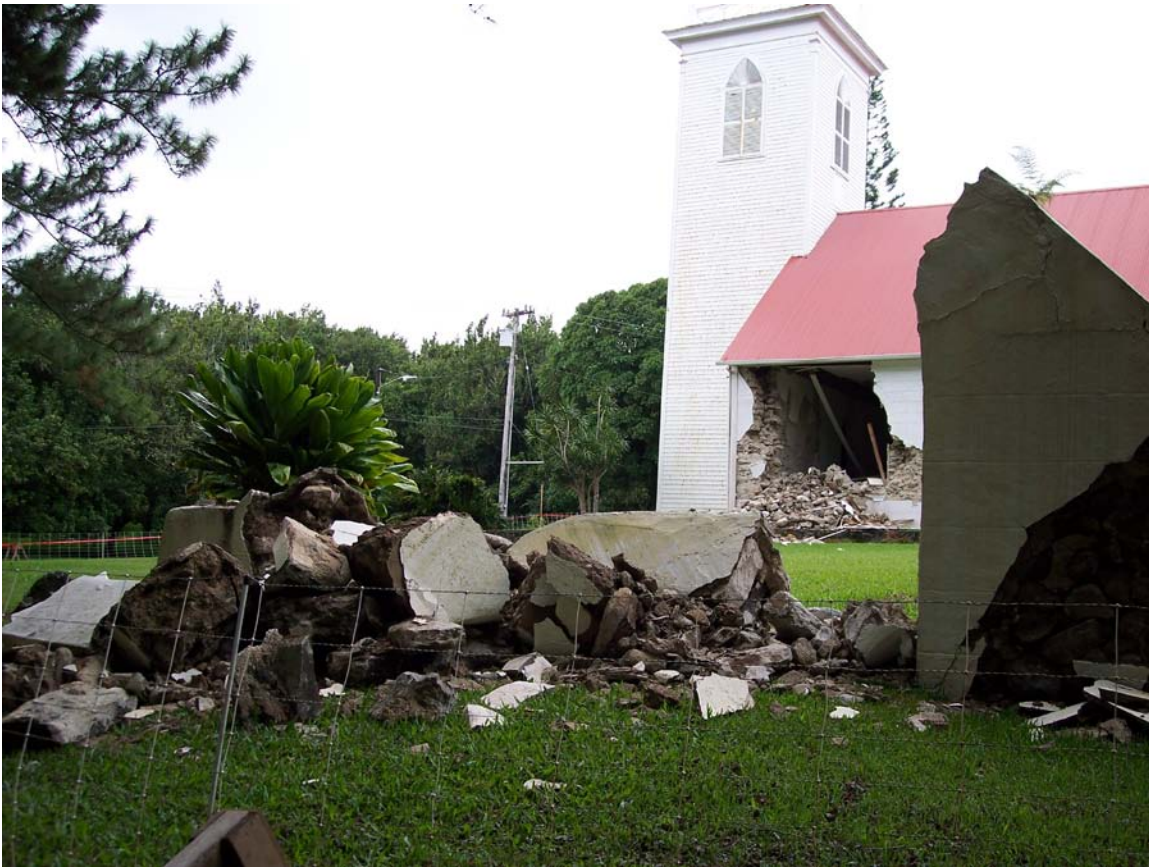
24.3. View (from the north side of the church) of fragments from the archway's former east base (view to the south-southeast). USGS photo by T.J. Takahashi, 10/20/2006 (tjt1364).

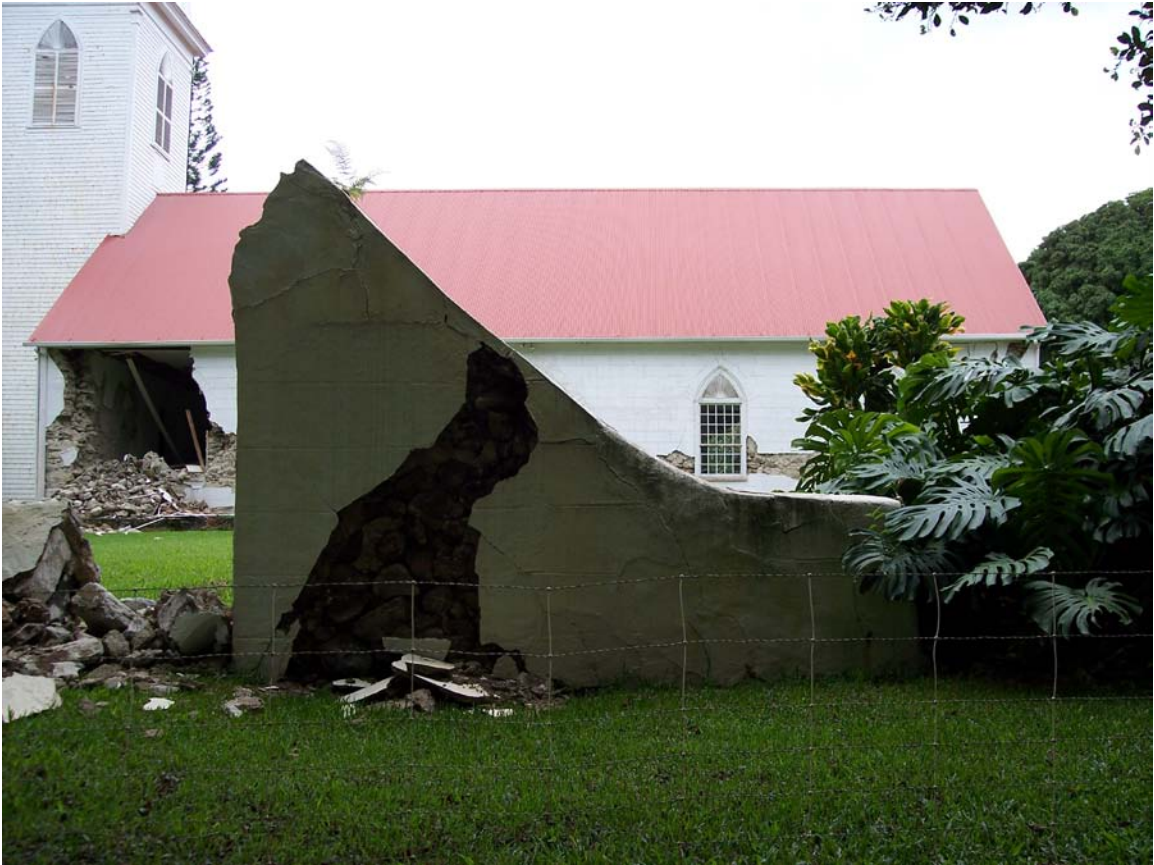
24.4. View of the cracked archway's rock-wall interior and its stucco façade (view to the south). USGS photo by T.J. Takahashi, 10/20/2006 (tjt1362).

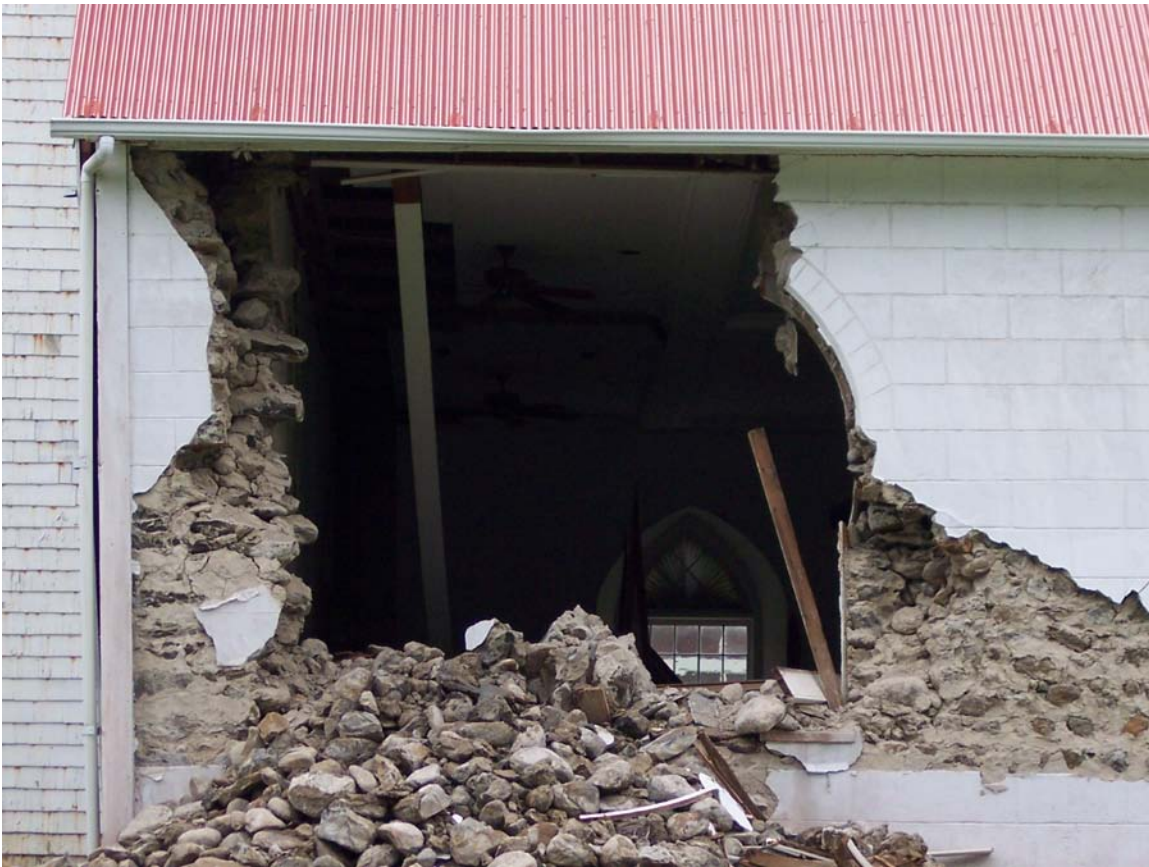
24.5. View of completely collapsed section of the northeast corner wall and exterior stucco of the church. Part of the collapsed ceiling is also visible through the opening (view to the south). USGS photo by T.J. Takahashi, 10/20/2006 (tjt1360).

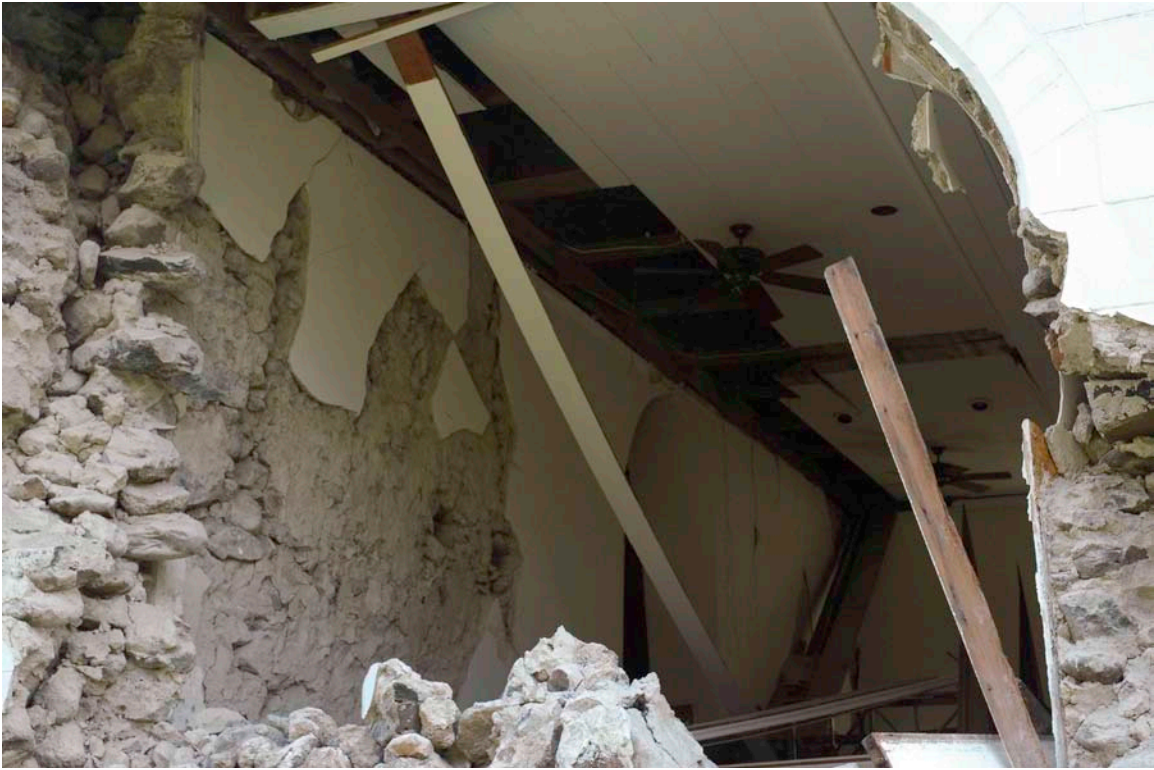
24.6. View of the damaged interior rock wall and ceiling, as seen through a gaping hole in the exterior, where a stained-glass window was situated (view to the east-northeast). CSAV photo by D.A. Whilldin, 10/19/2006 (daw075).

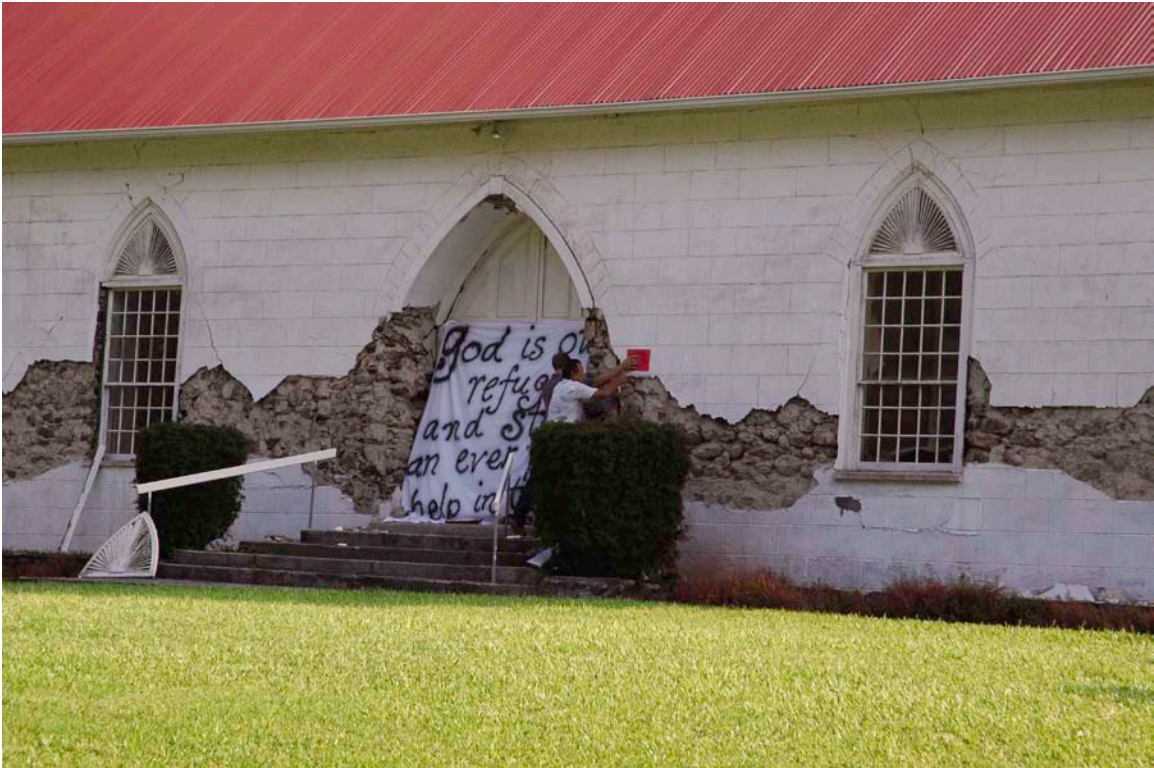
24.8. Profile view of the damage at the church's front entrance (view to the south-southwest). USGS photo by T.J. Takahashi, 10/20/2006 (tjt1366).

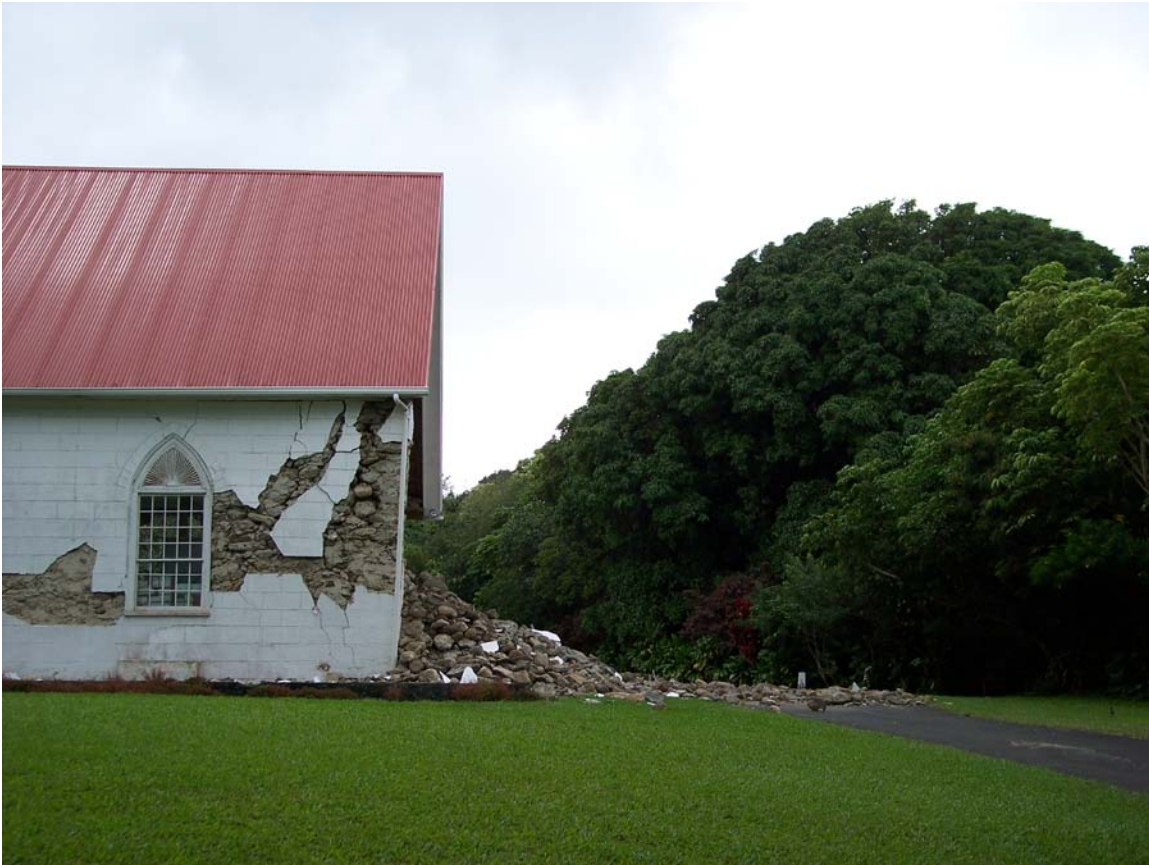
24.9. View of the extensive damage to the church's front entrance (west side) and to the rock wall and stucco exterior of the north wall (view to the southeast). USGS photo by T.J. Takahashi, 10/20/2006 (tjt1370).

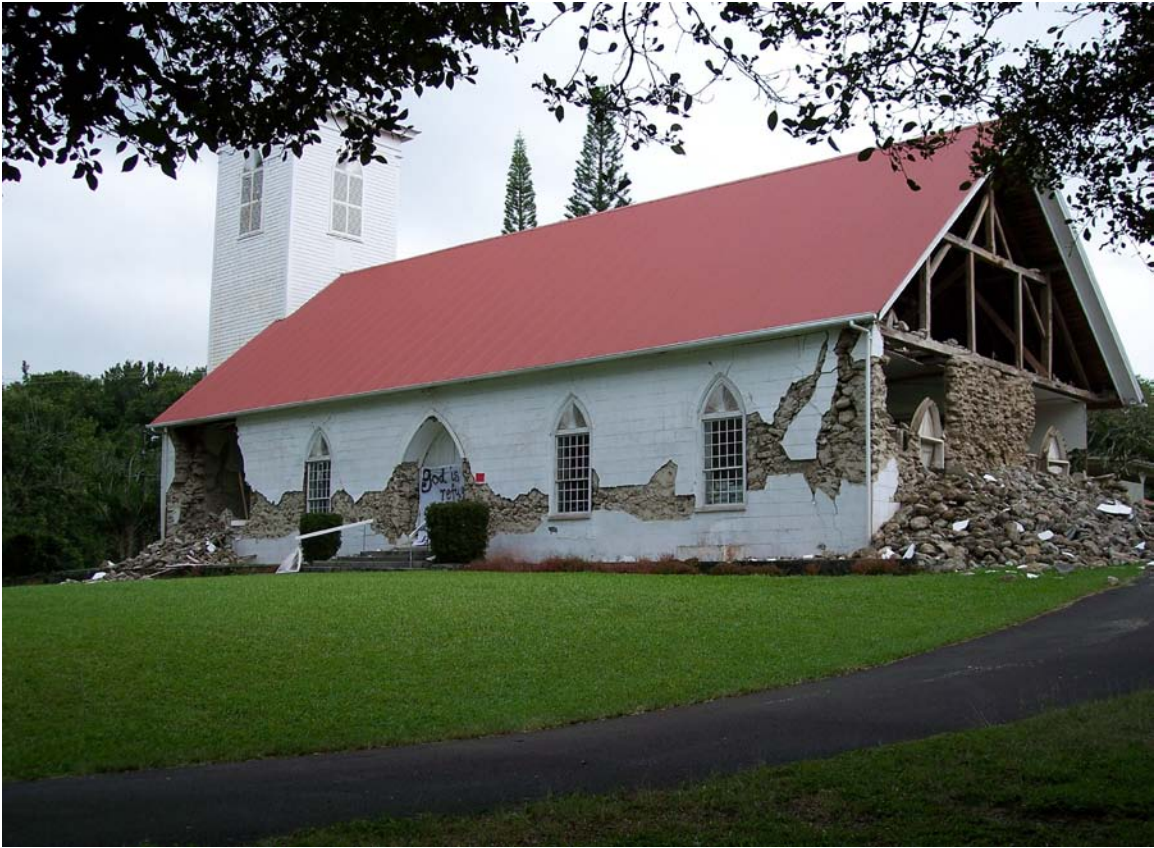
24.10. View of the church's front entrance, showing the collapsed wall under the eave, framing, and wall above the doors (view to the east-southeast). USGS photo by T.J. Takahashi, 10/20/2006 (tjt1371).

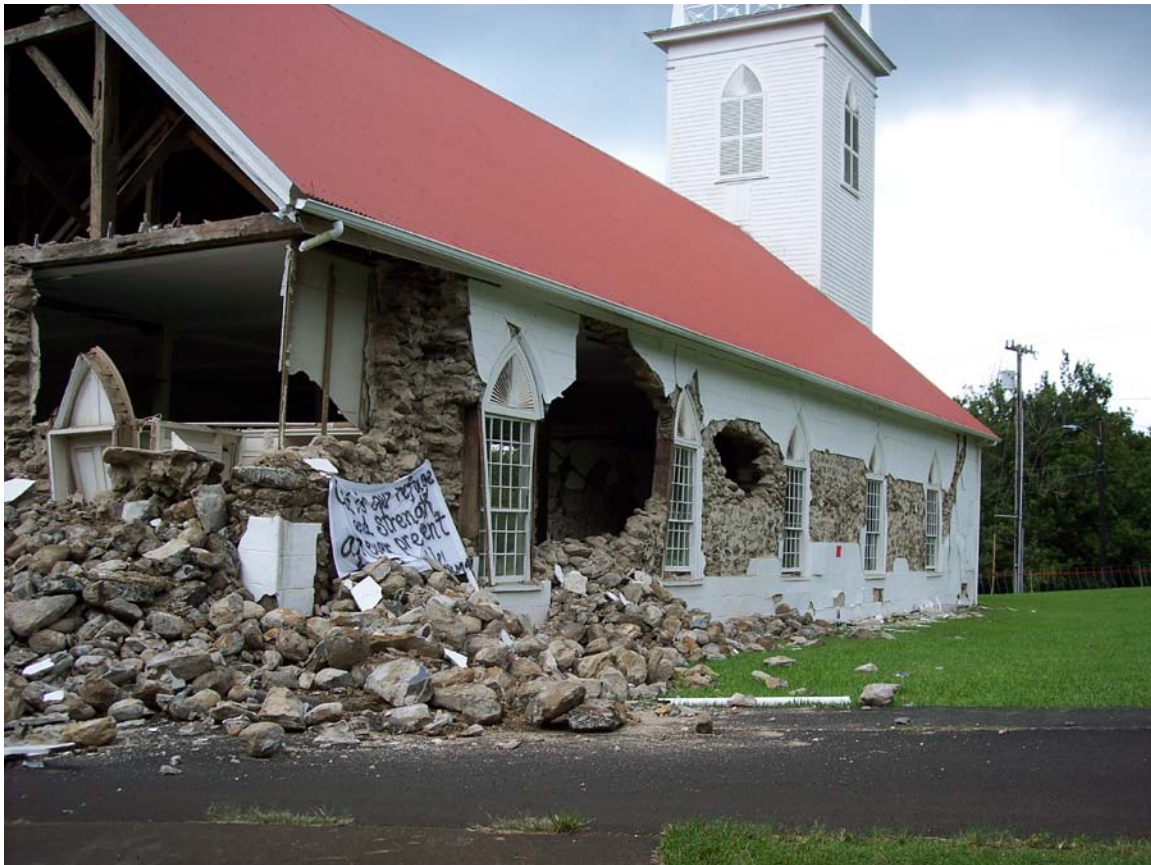
24.12. Close-up view of the collapsed southwest corner wall and the church's interior. The framing for the windows literally held up the church (view to the north-northeast). USGS photo by T.J. Takahashi, 10/20/2006 (tjt1375).

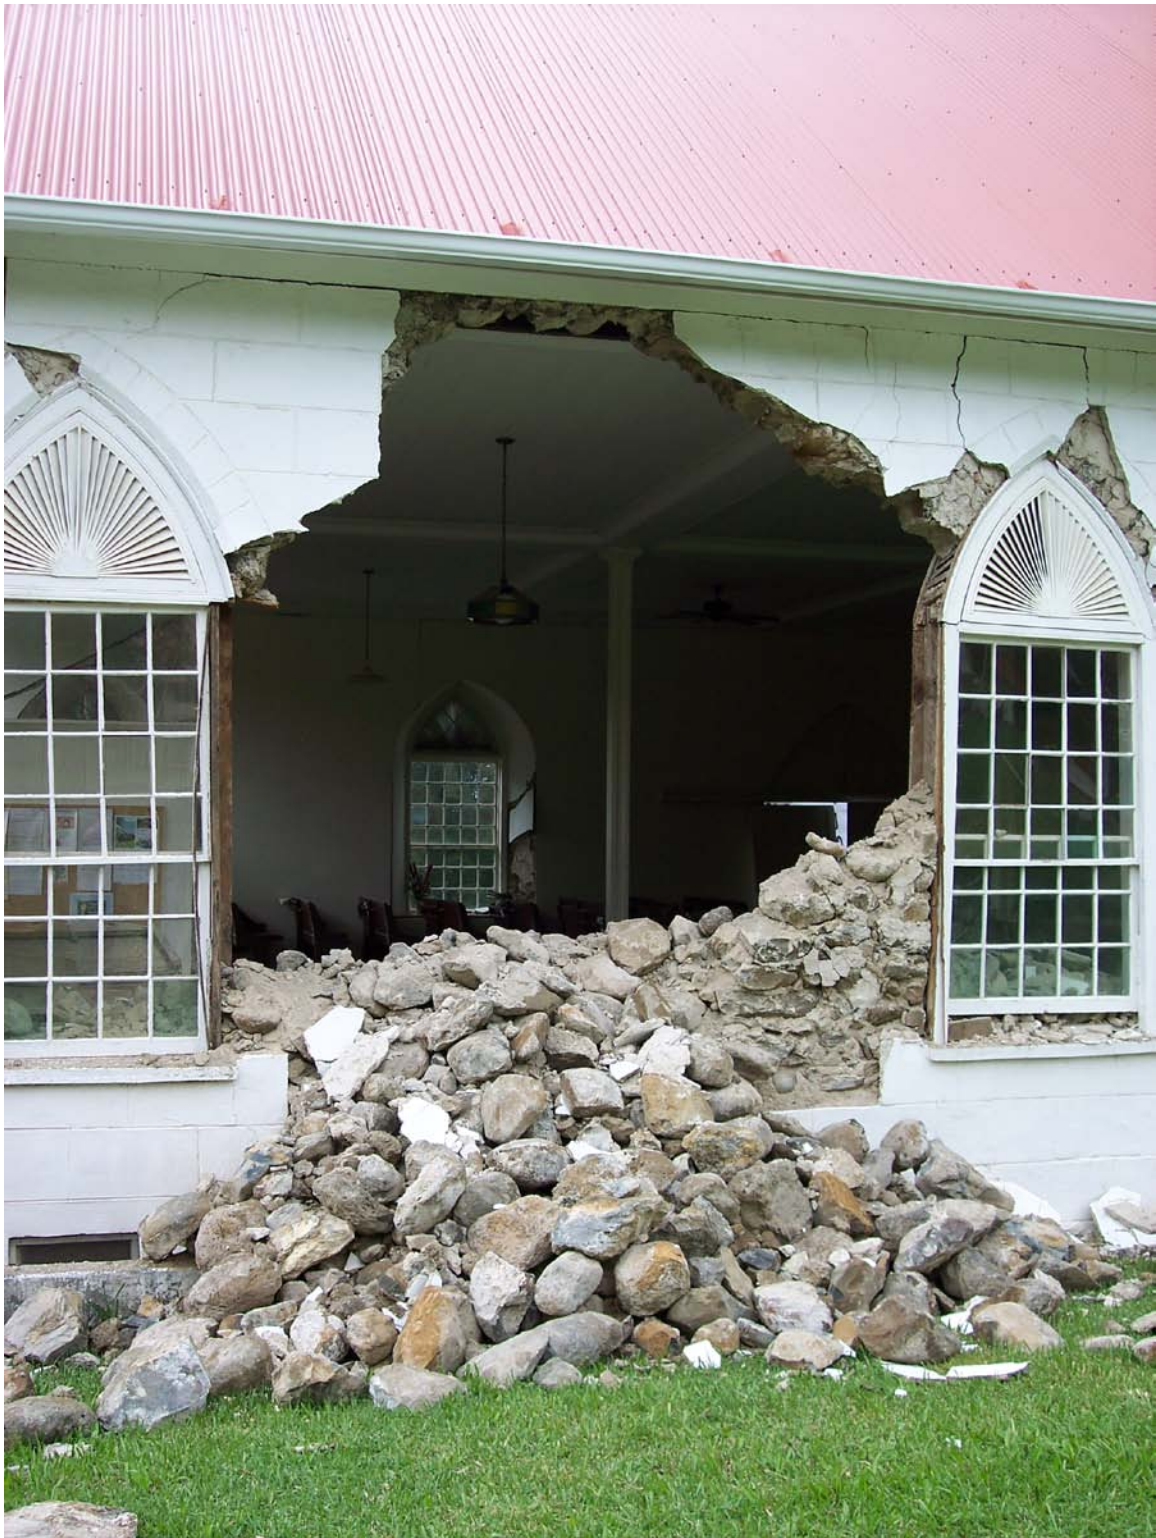
24.13. View of HVO volunteer looking at the damage to the interior, beyond the red-posted notice (structure unsafe to enter or occupy) on the south wall of the church (view to the northeast). USGS photo by T.J. Takahashi, 10/20/2006 (tjt1378).
